# Test Report

Project ID: 20210322-001718

<b>Test Sponsor:</b>	Evolution Fasteners
<b>Sponsor Address:</b>	2A & 2B Clyde Gateway Trade Park Dalmarnock Rd Rutherglen Glasgow G73 1AN
<b>Date of Test:</b>	30 June 2021

The specimen had overall nominal dimensions of 3000 mm wide by 3050 mm high by 272 mm thick and was formed from 72 mm deep Metsec steel stuck framing and 25 mm thick Knauf mineral wool insulation, lined with two layers of 12.5 mm thick Knauf Aquapanel wallboard to each side. 150 mm thick Rockwool insulation panels were affixed to the unexposed surface. The specimen incorporated assorted Evolution Fasteners fixings.

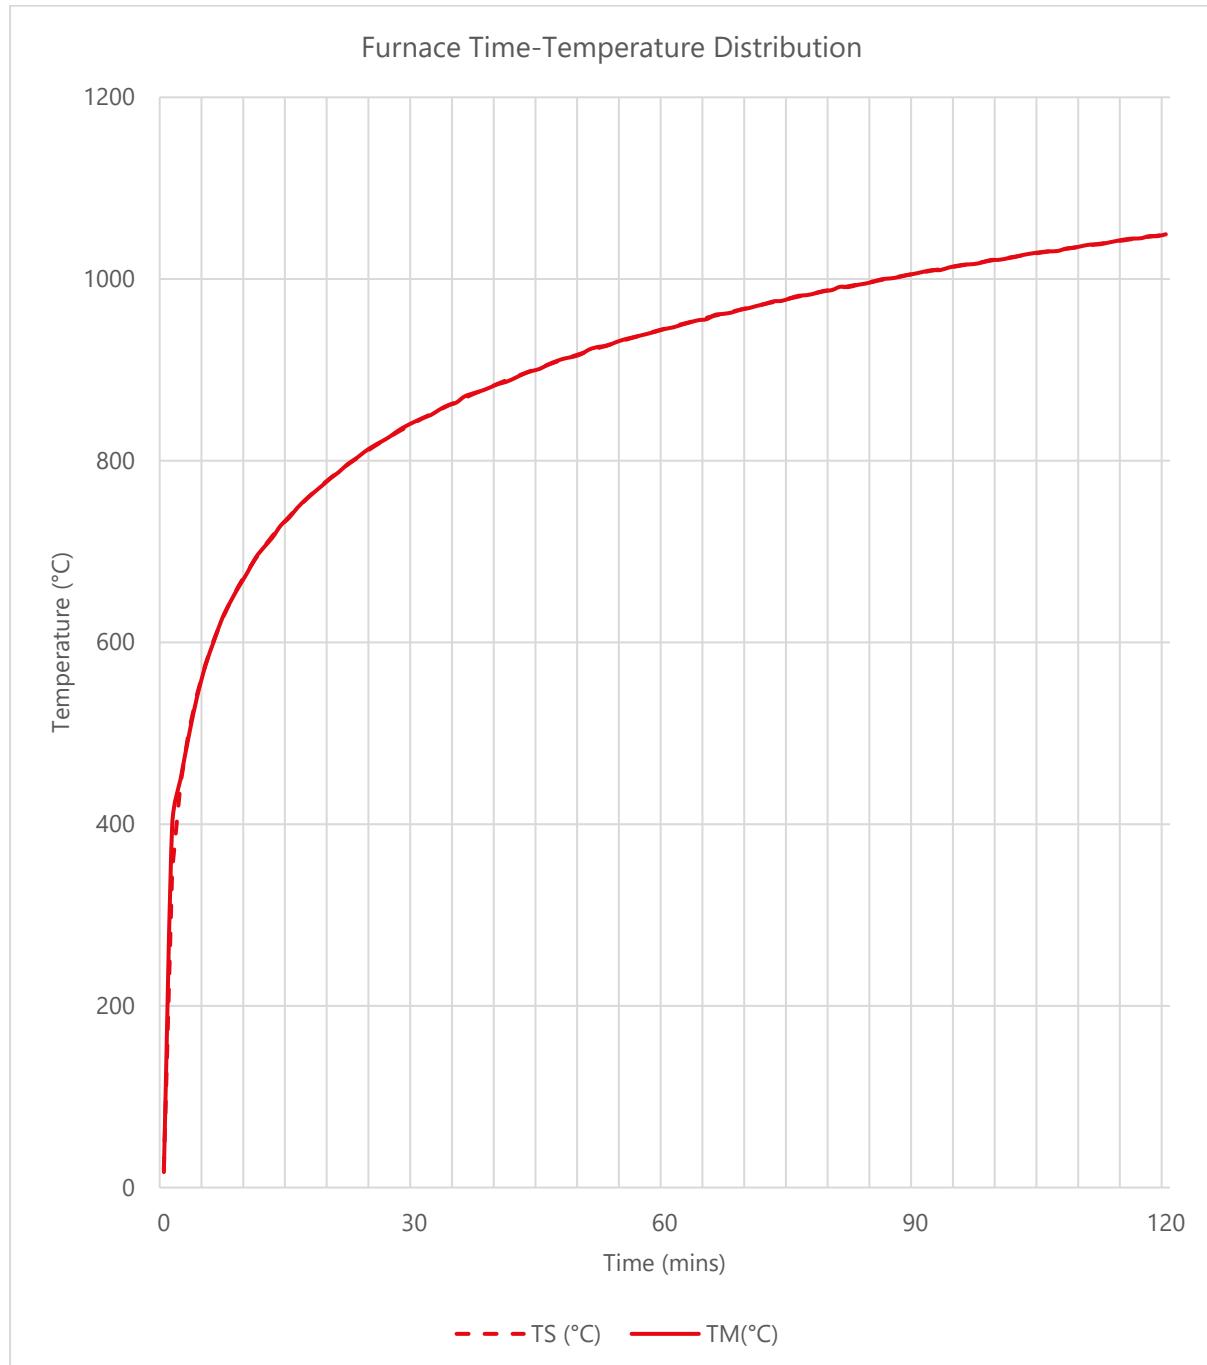
The specimen(s) were subject to heating conditions in accordance with BS EN 1363-1:2020 § 5.1. This was monitored and controlled for the duration of the test using eight type K thermocouples which were uniformly distributed across a vertical plane  $100 \pm 50$  mm from the exposed face of the test construction. The resulting Time-Temperature distribution is presented below. Refer to Appendix B.1 for the full details of the temperatures recorded.

Figure 1 Time-Temperature Distribution

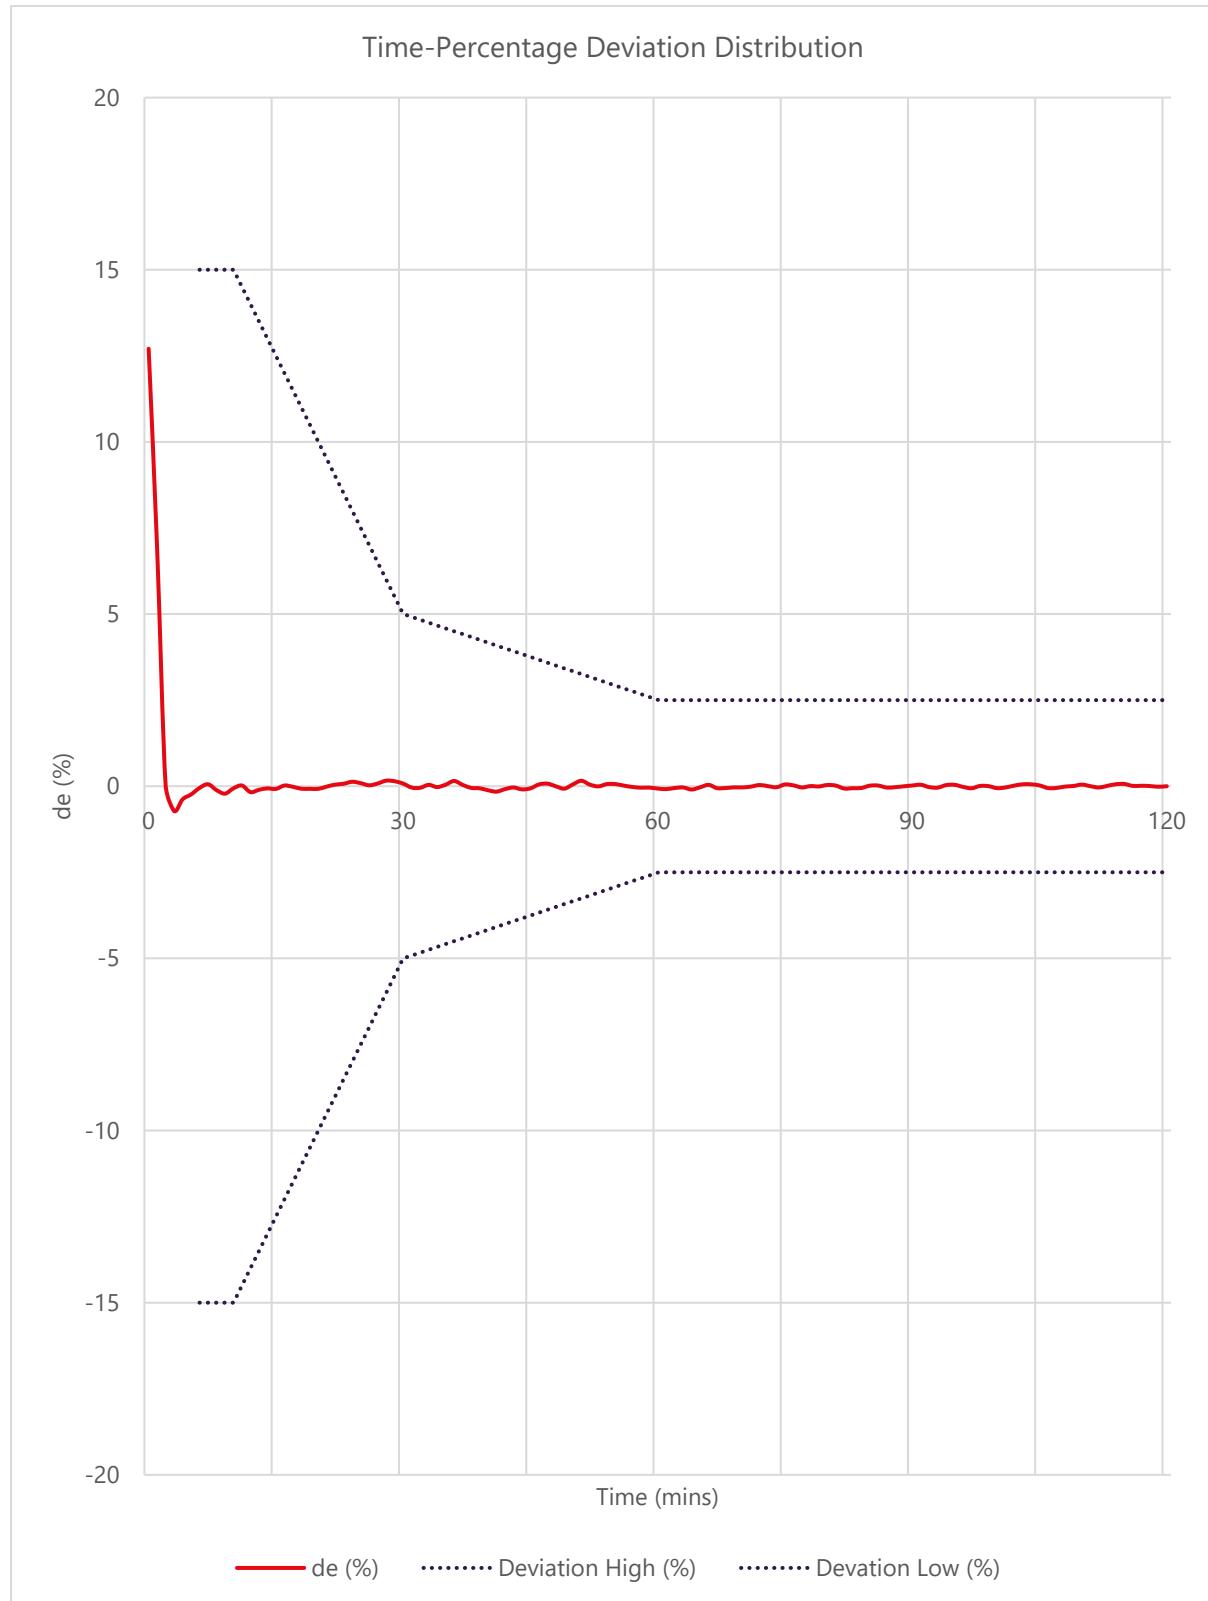
The percentage deviation of the resulting time-temperature curve has been evaluated against the standard time-temperature curve in accordance with BS EN 1363-1:2020 § 5.1.2. The Time-Percentage Deviation is presented below.

Figure 2 Time-Percentage Deviation Distribution

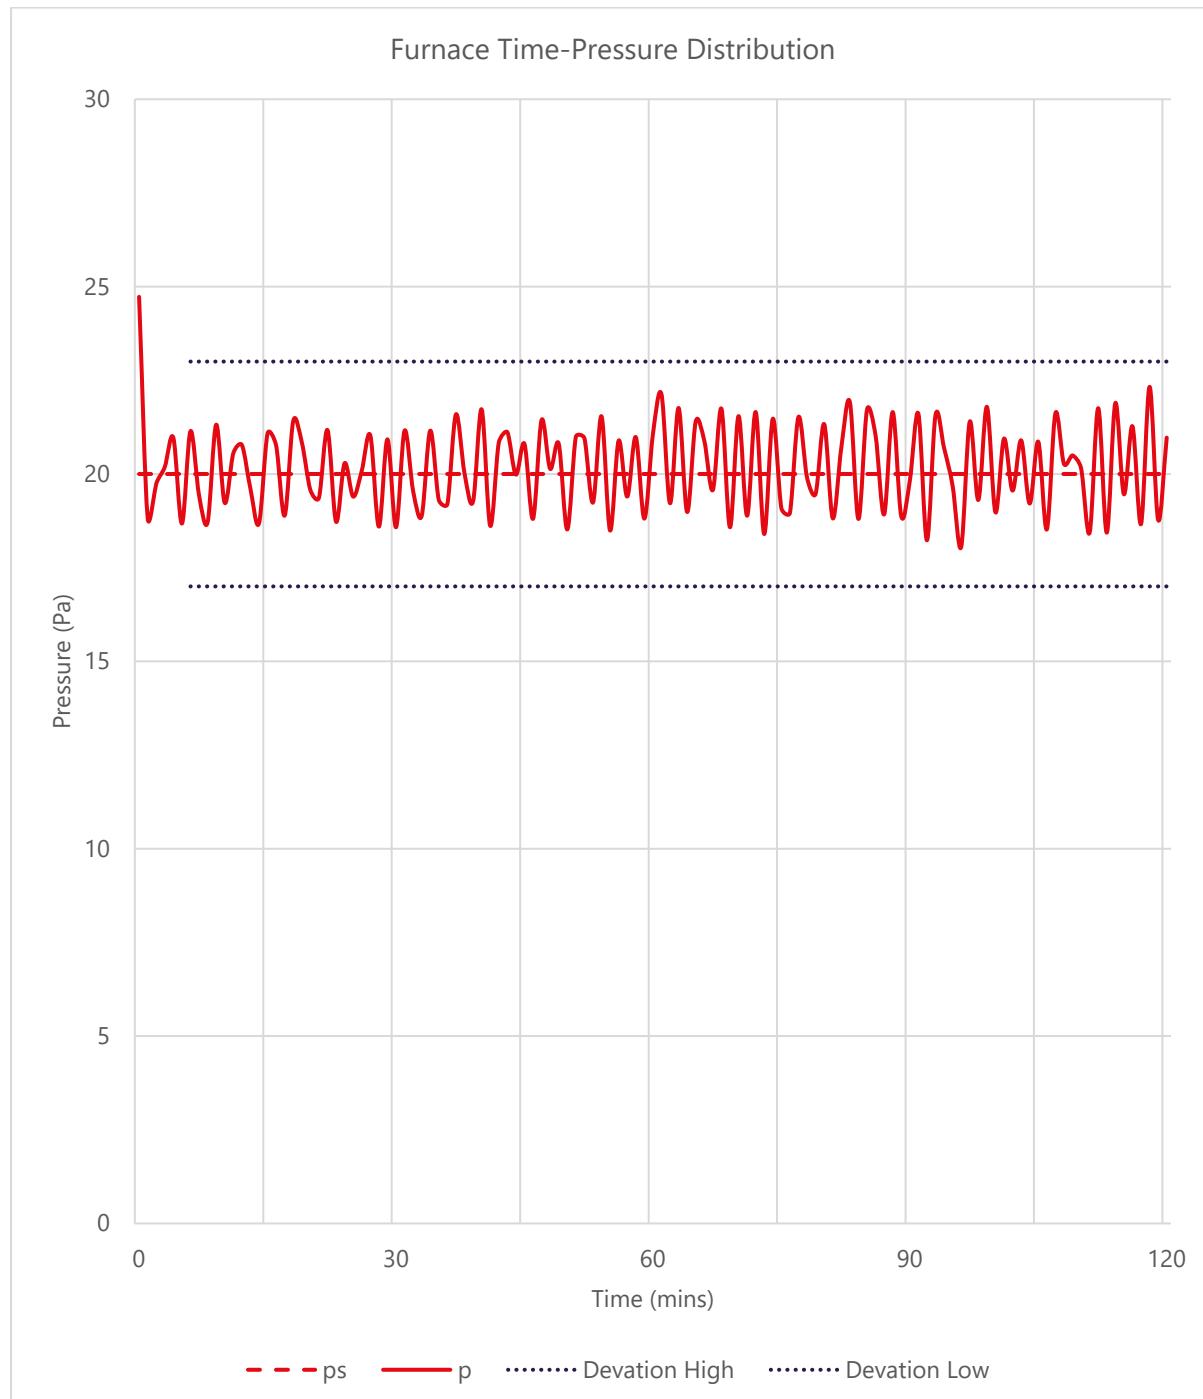
The specimen(s) were subject to a pressure regime in accordance with BS EN 1363-1:2020 § 5.2. This was monitored and controlled for the duration of the test via a pressure sensing head located at 2850 mm from the furnace floor. The Time-Pressure distribution is presented below.

Figure 3 Time-Pressure Distribution of Furnace

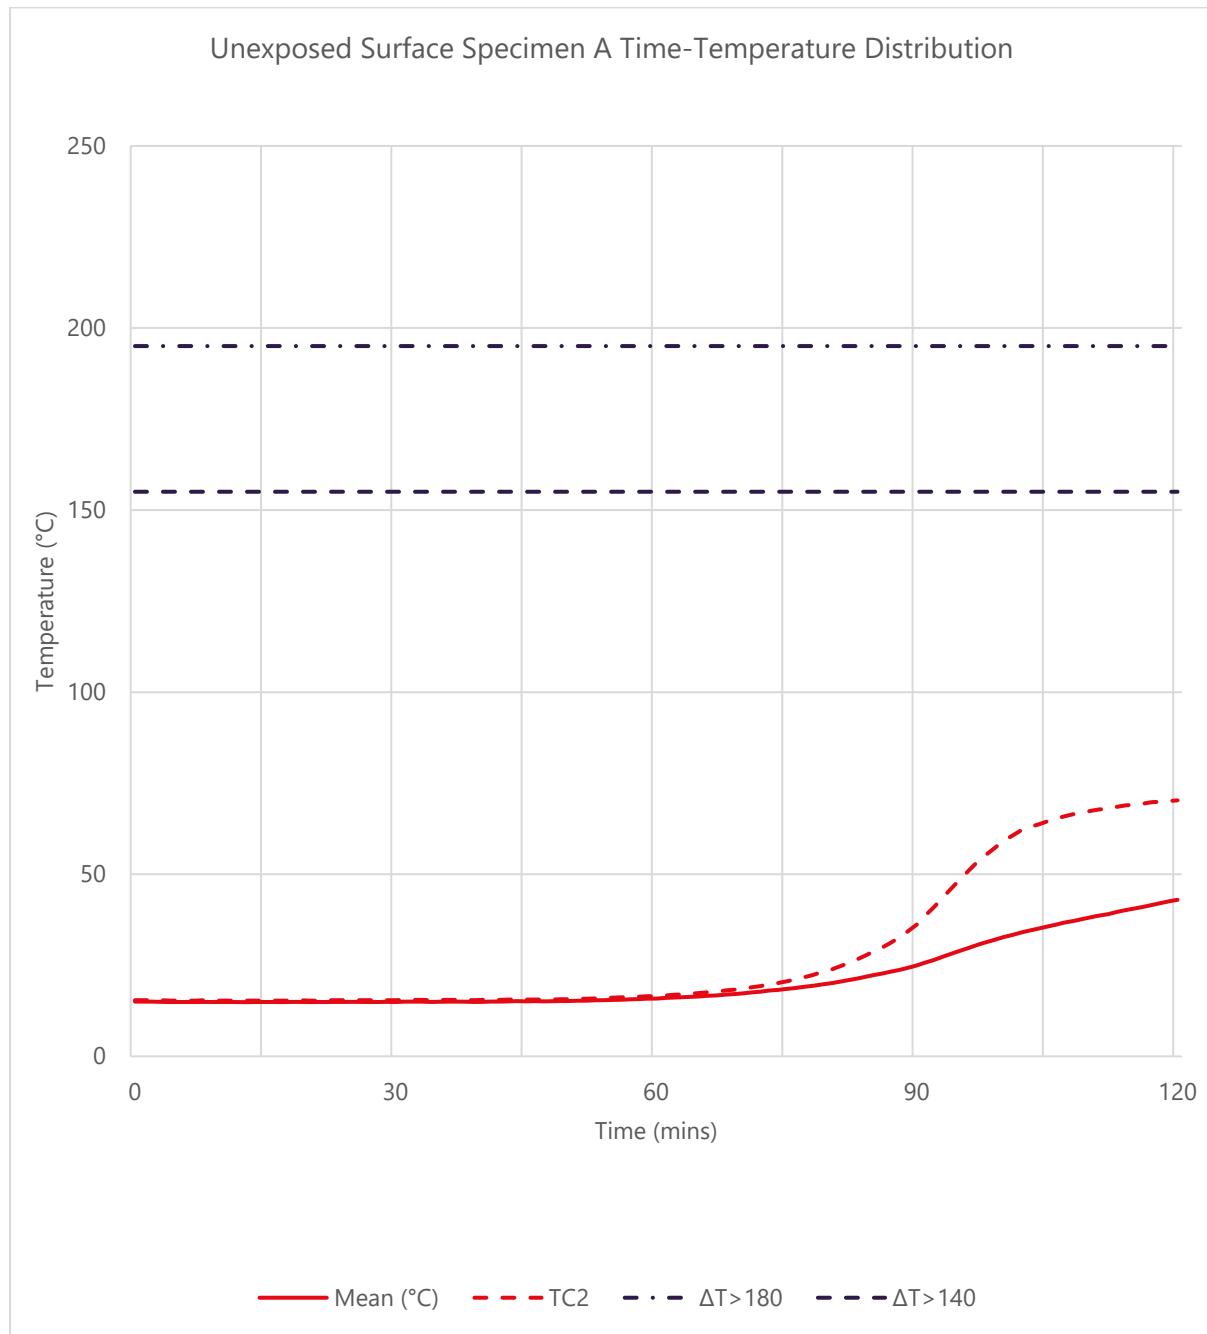
Disc thermocouples were affixed to the unexposed surface of the specimen(s) in accordance with BS EN 1363-1:2020 § 9.1.2 to measure and monitor the maximum and the mean temperature rise of the unexposed face of the specimen for the duration of the test. The resulting time-temperature distribution and a summary of the key results is presented below. Refer to appendix B.1 for full details of temperatures recorded.

Figure 4 Time-Temperature Distribution of Unexposed Face

Time (mins)	T1	T2	T3	T4	T5	T6	T7	T8	T9	T10	T11
0	15.3	15.4	14.8	15.1	14.6	15.0	15.7	15.7	15.3	15.8	15.2
5	15.1	15.3	14.6	15.0	14.6	14.9	15.6	15.6	15.2	15.6	15.1
10	15.1	15.3	14.6	15.0	14.6	14.9	15.7	15.7	15.1	15.6	15.1
15	15.1	15.3	14.6	15.0	14.6	15.0	16.0	16.0	15.1	15.6	15.0
20	15.1	15.3	14.5	15.0	14.6	15.0	16.4	16.3	15.1	15.6	15.0
25	15.1	15.4	14.6	15.0	14.7	15.1	16.8	16.7	15.1	15.6	15.0
30	15.1	15.4	14.5	15.0	14.6	15.1	17.4	17.1	15.1	15.7	15.1
35	15.2	15.5	14.6	15.0	14.6	15.2	18.0	17.6	15.1	15.9	15.2
40	15.1	15.5	14.6	15.0	14.6	15.3	18.7	18.2	15.1	16.2	15.3
45	15.4	15.6	14.7	15.1	14.7	15.5	19.7	19.2	15.3	16.8	15.6
50	15.5	15.7	14.8	15.2	14.8	15.9	20.8	20.6	15.4	17.5	16.0
55	15.9	16.1	15.1	15.4	15.0	16.5	22.4	23.1	15.7	18.9	16.8
60	16.5	16.5	15.5	15.6	15.2	17.5	24.7	26.2	16.2	20.7	17.9
65	17.3	17.4	16.1	15.9	15.6	19.0	28.0	30.3	16.9	23.2	19.4
70	18.4	18.6	17.0	16.3	16.2	21.1	31.8	34.7	18.2	26.4	21.3
75	20.0	20.6	18.3	16.8	16.9	23.6	35.8	39.0	19.8	29.9	23.6

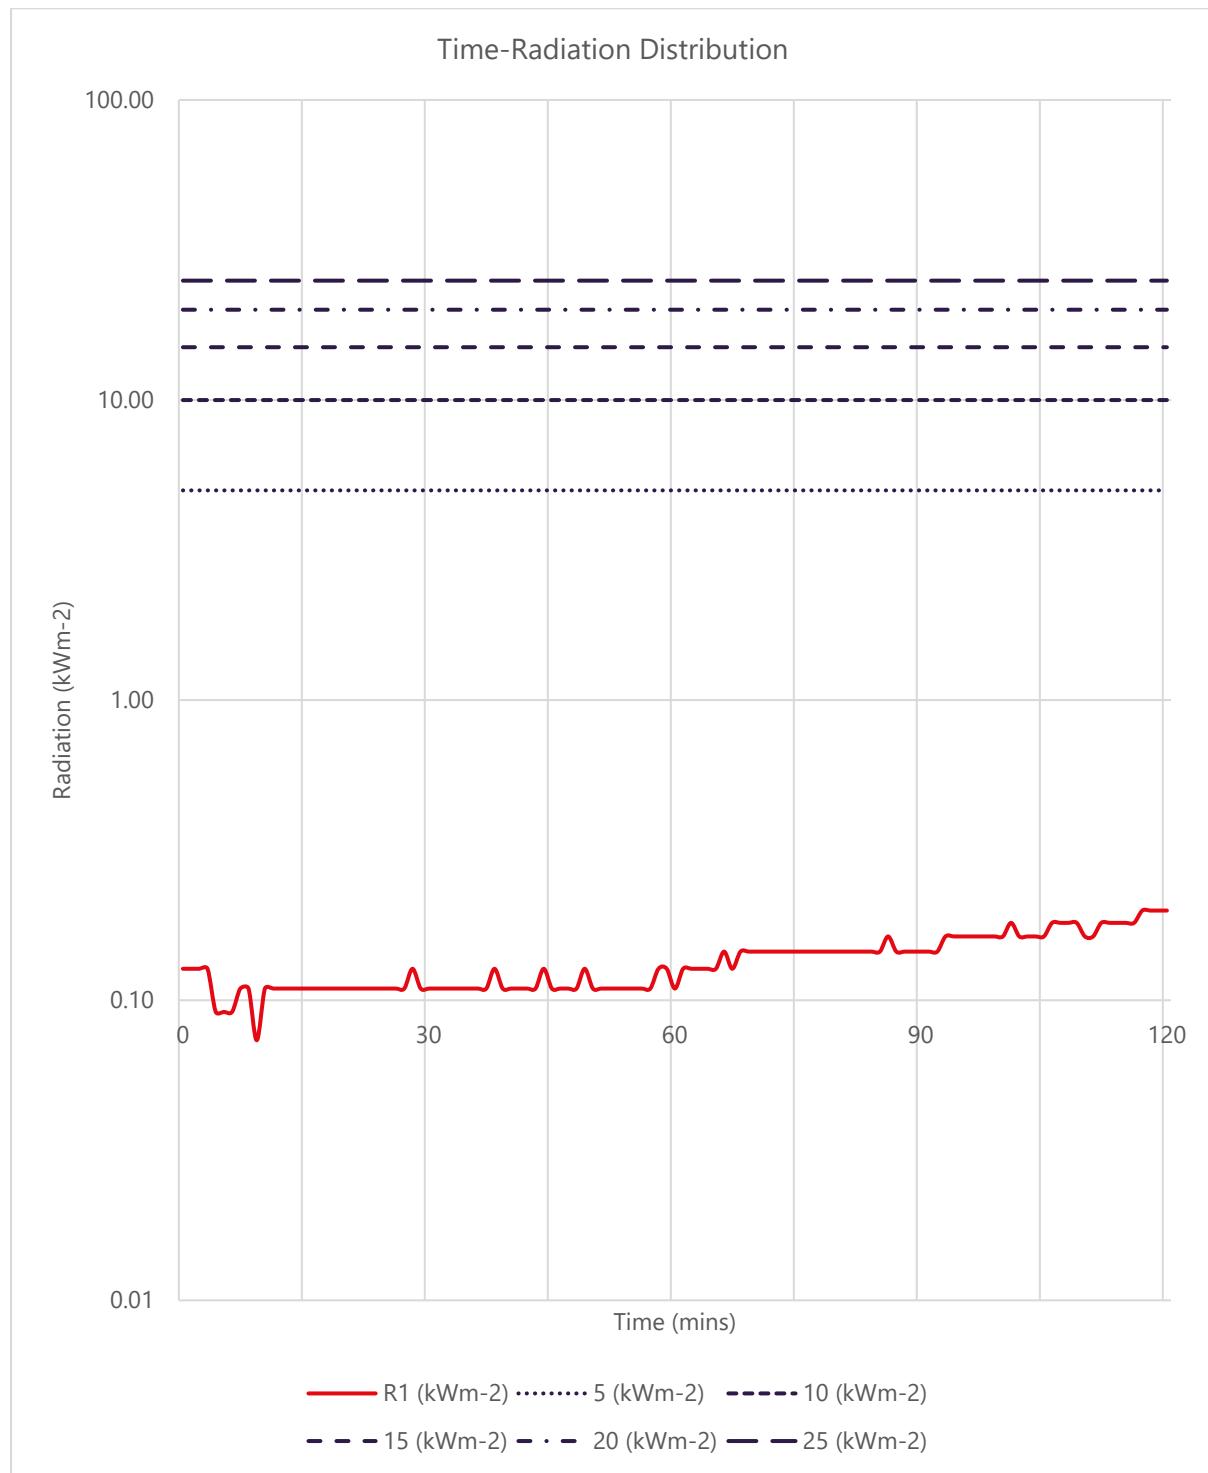
The radiation of the specimen was measured using a 180° field of view, water cooled heat flux meter. This was positioned in accordance with BS EN 1363-2:1999 § 8 to evaluate the average radiation of the specimen for the duration of the test. The Time-Radiation distribution is presented below. Refer to Appendix B.2 for full details of the radiation recorded.

Figure 5 Time-Radiation Distribution of Unexposed Face

Time (mins)	R1 ( $\text{kWm}^{-2}$ )
0	0.127
5	0.091
10	0.109
15	0.109
20	0.109
25	0.109
30	0.109
35	0.109
40	0.109
45	0.109
50	0.109
55	0.109
60	0.109
65	0.127
70	0.145
75	0.145
80	0.145
85	0.145
90	0.145
95	0.163
100	0.163
105	0.163
110	0.163
115	0.181

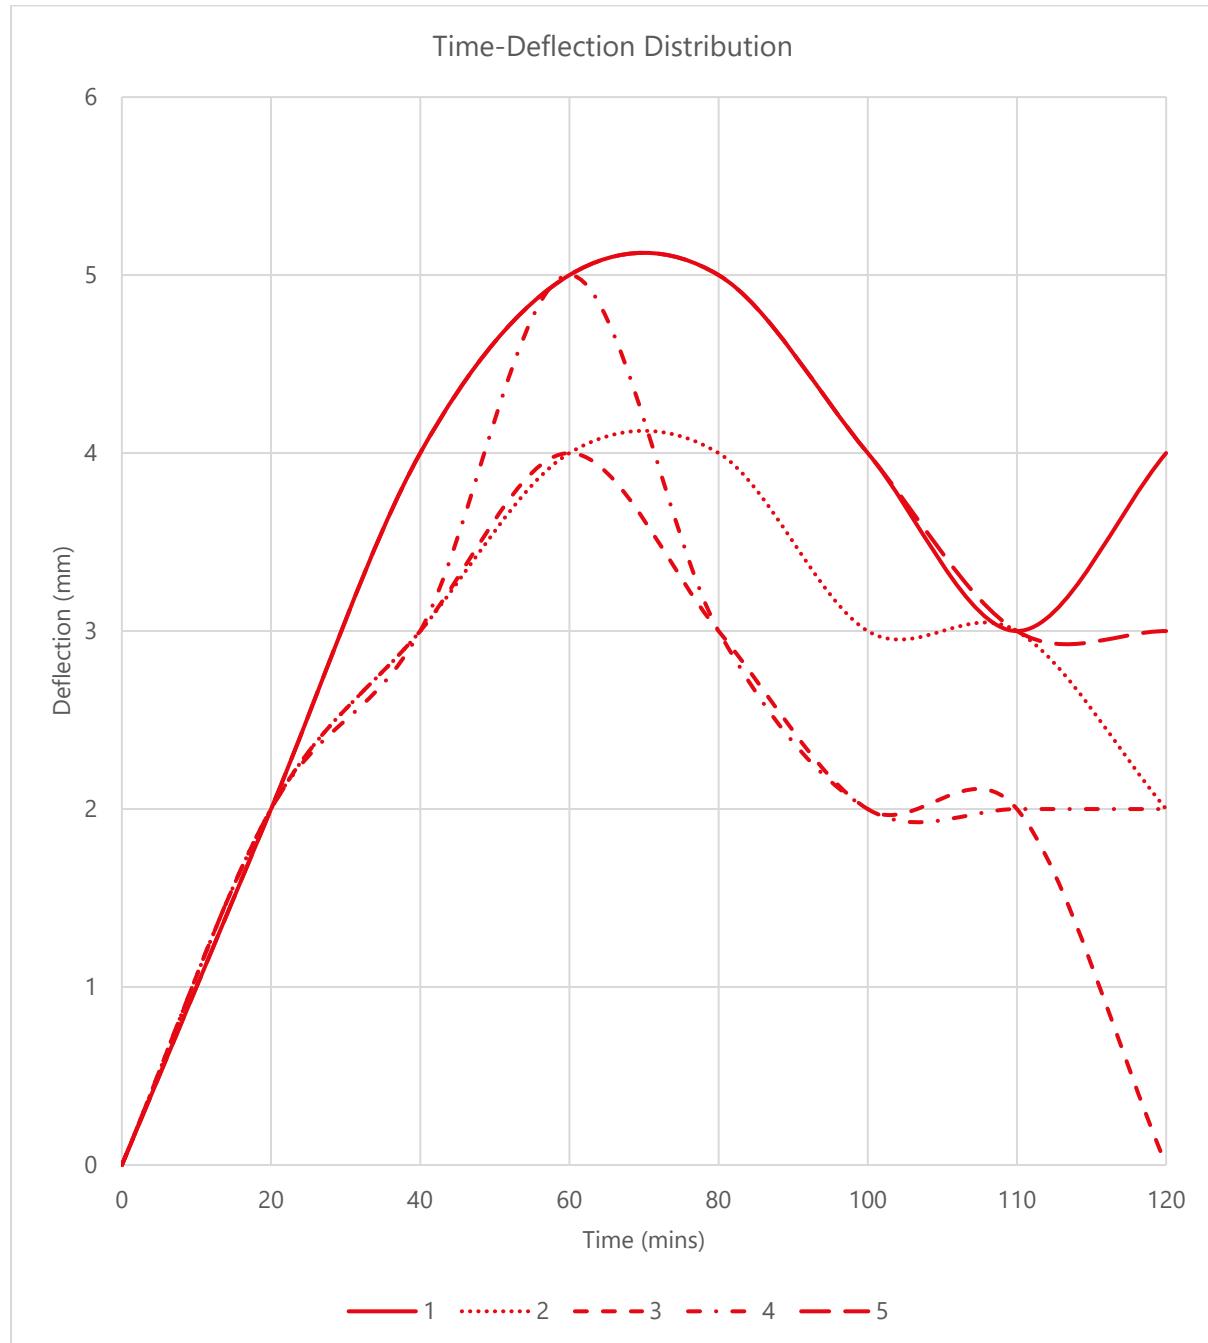
A levelling line laser was positioned along a plane parallel to the specimen to provide a fixed datum for the measurement of deflection in accordance BS EN 1363-1: 2020 § Annex G. Measurements were recorded at intervals for the duration of the test and recorded on a Deflection Measurement Record. The results are presented below. Refer to Appendix A.3 for details on measurement locations and B.4 for full details on the measurements recorded.

N.B: positive values indicate movement toward the heating conditions.

Figure 6 Time-Deflection Distribution

Time (mins)	D1 (mm)	D2 (mm)	D3 (mm)	D4 (mm)	D5 (mm)
0	0	0	0	0	0
20	2	2	2	2	2
40	4	3	3	3	4
60	5	4	4	5	5
80	5	4	3	3	5
100	4	3	2	2	4
110	3	3	2	2	3
120	4	2	0	2	3

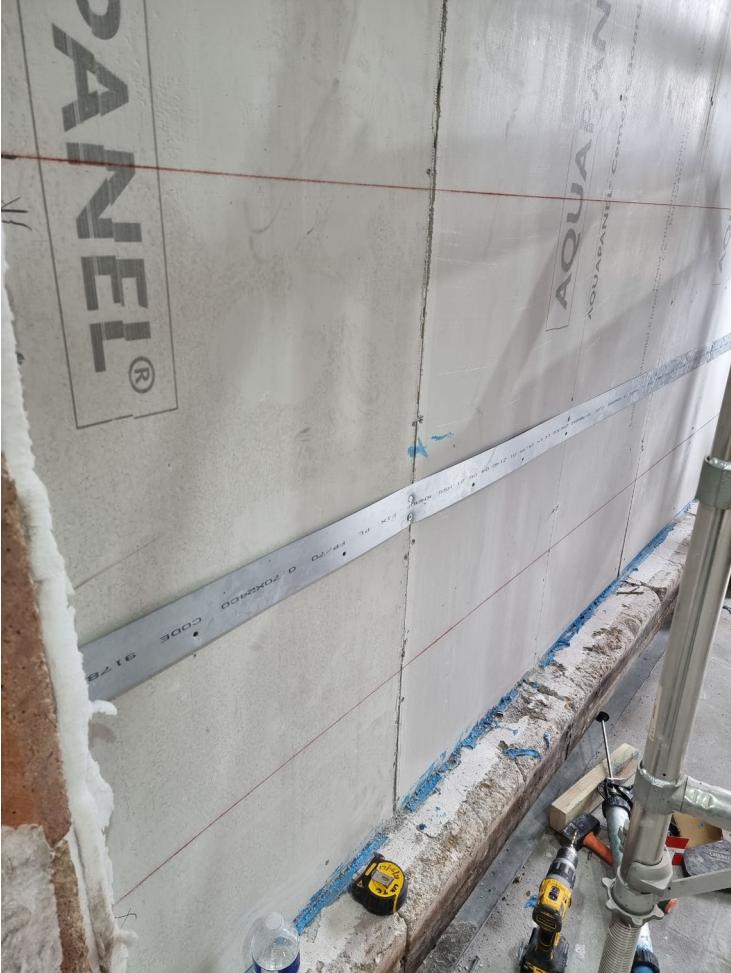
1 Inner Wallboards

<b>Manufacturer</b>	Knauf
<b>Reference</b>	Aquapanel Cement Board - Indoor
<b>Material</b>	Glass Fibre Reinforced Cement
<b>Dimensions (w x l x d)</b>	1200 x 2400 x 12.5
<b>Density (kg/ m<sup>3</sup>)</b>	880 <sup>5</sup>
<b>Fixing</b>	Wing Drill Screw Fixed @ max 300 mm C/C

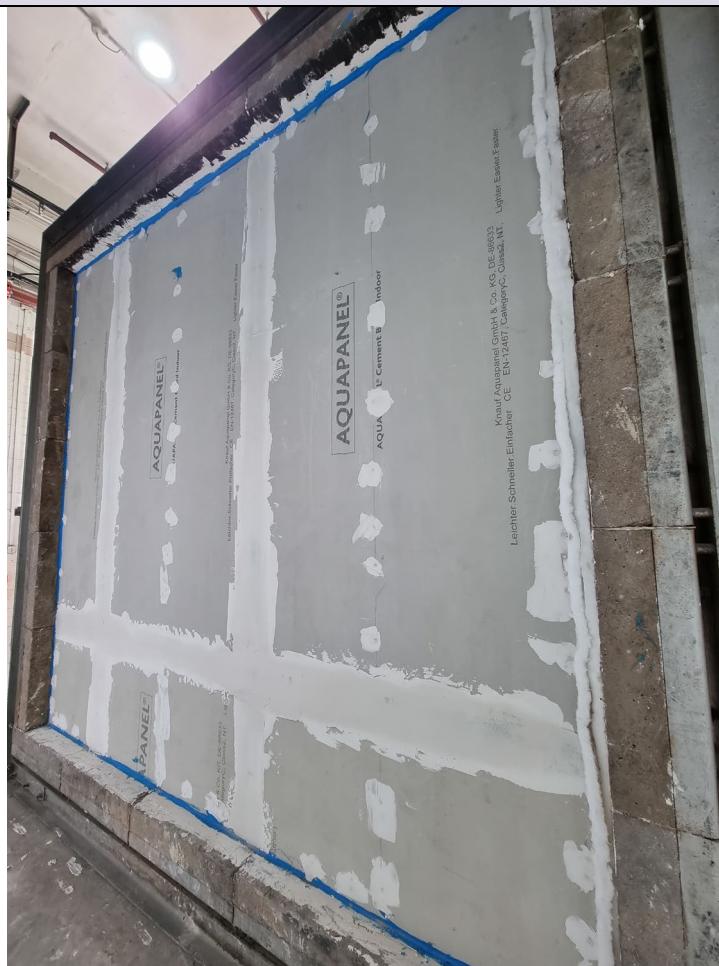
## 2 Outer Wallboards

<b>Manufacturer</b>	Knauf
<b>Reference</b>	Aquapanel Cement Board - Indoor
<b>Material</b>	Glass Fibre Reinforced Cement
<b>Dimensions (w x l x d)</b>	1200 x 2400 x 12.5
<b>Density (kg/ m<sup>3</sup>)</b>	880 <sup>6</sup>
<b>Fixing</b>	Wing Drill Screw Fixed @ max 300 mm C/C

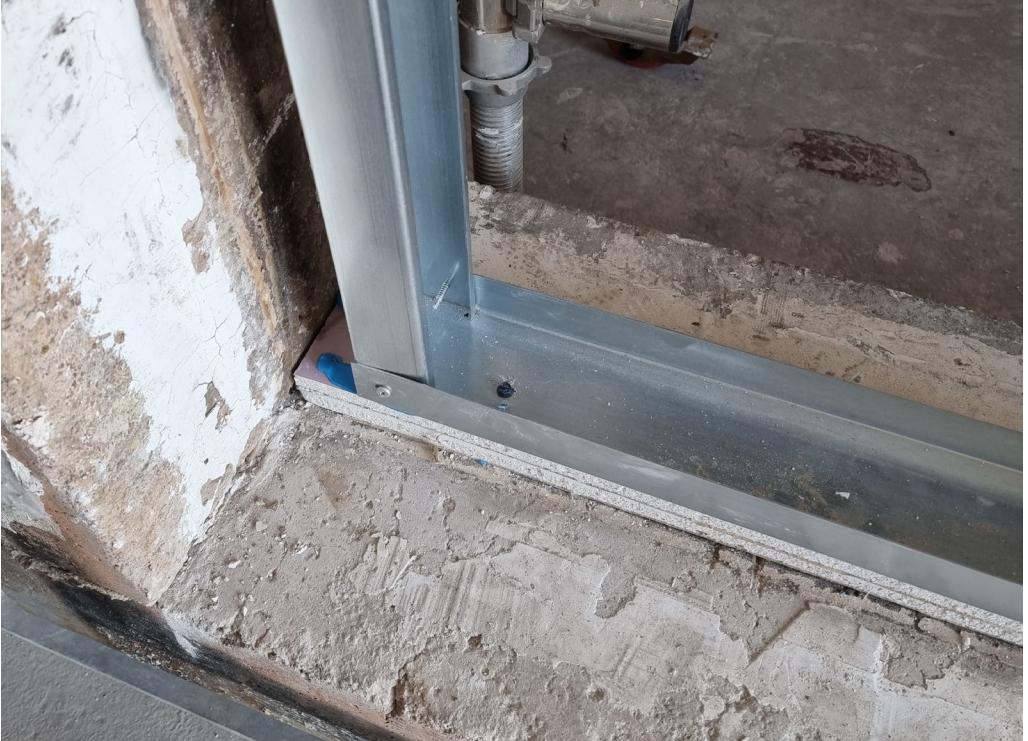
<b>3 Floor Track</b>

<b>Manufacturer</b>	Metsec
<b>Reference</b>	90M12-40
<b>Material</b>	Galvanised Steel
<b>Dimensions (w x h x t)</b>	72 X 40 x 1.2
<b>Fixing(s)</b>	Screw fixed at each vertical stud

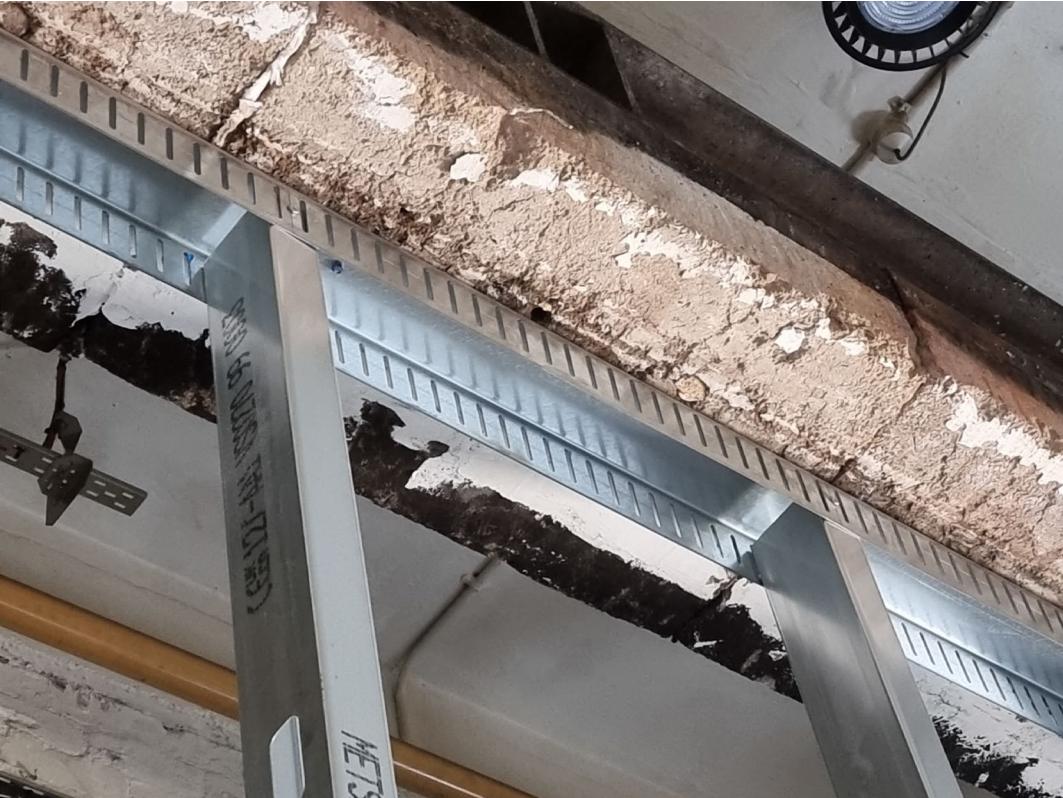
<b>4 Ceiling Track</b>

<b>Manufacturer</b>	Metsec
<b>Reference</b>	94M16S – Slotted Head Track
<b>Material</b>	Galvanised Steel
<b>Dimensions (w x h x t)</b>	72 x 70 x 1.2
<b>Fixing(s)</b>	Tek screw to each stud flange

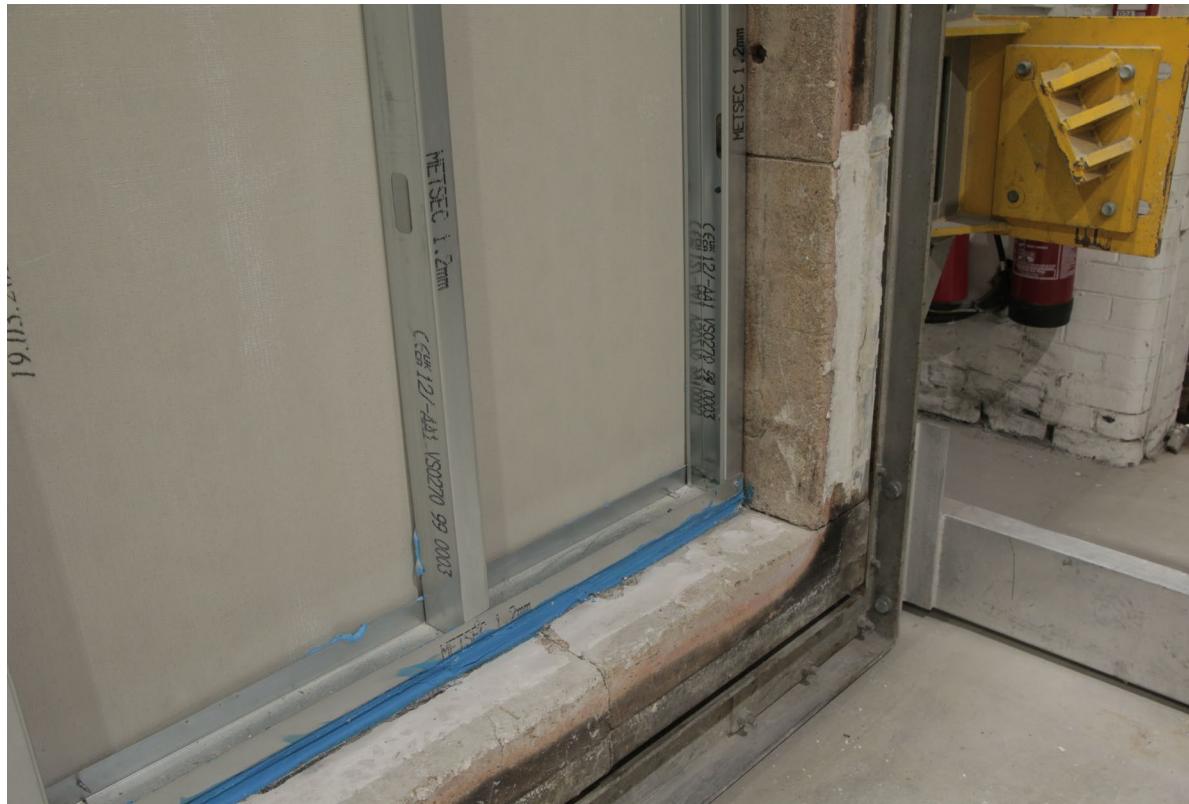
**5 'C' Studs**

<b>Manufacturer</b>	Metsec
<b>Reference</b>	90M12-50 Metsec Stud Section
<b>Material</b>	Galvanised Steel
<b>Dimensions (w x d x t)</b>	90 x 48 x 1.2
<b>Fixing(s)</b>	Screw fixed to floor/ceiling track

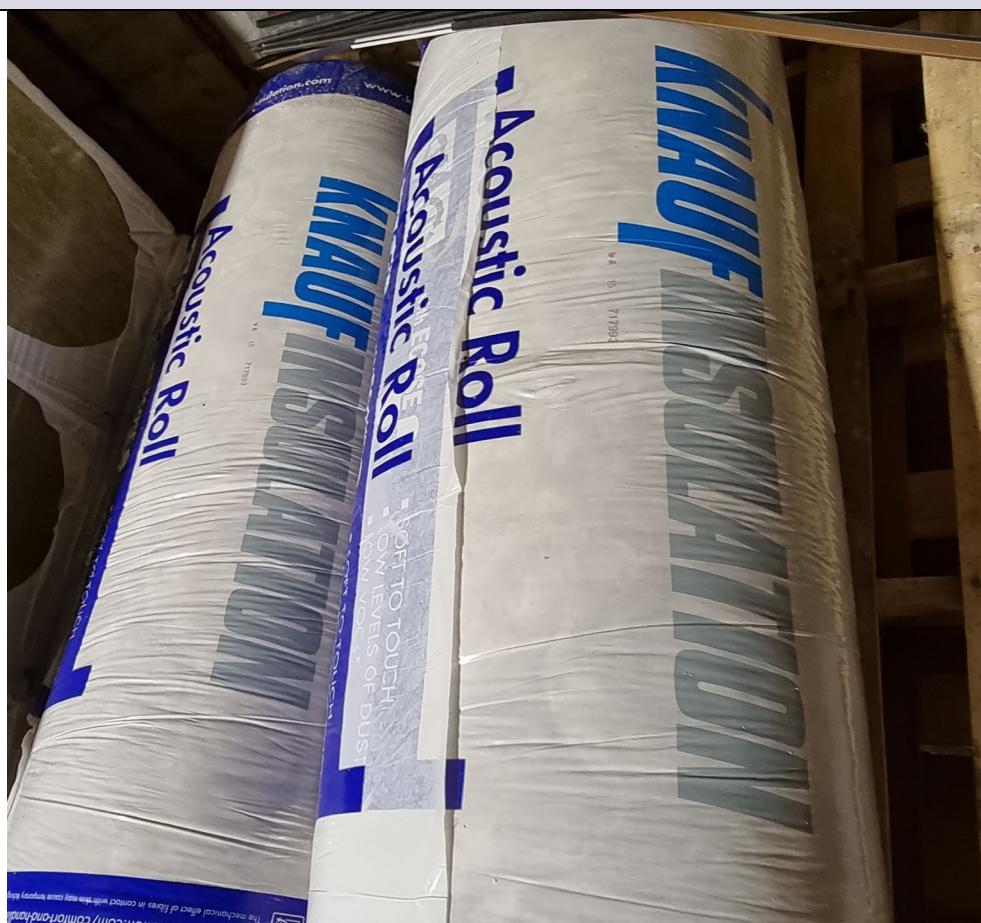
**6 Cavity Insulation**

<b>Manufacturer</b>	Knauf
<b>Reference</b>	Glass Mineral Wool Insulation Acoustic Roll – 25mm 2400366
<b>Material</b>	Glass Mineral Wool
<b>Dimensions (w x l x t)</b>	600 x 1000 x 25
<b>Fixing(s)</b>	Compression fitted between 'C' studs

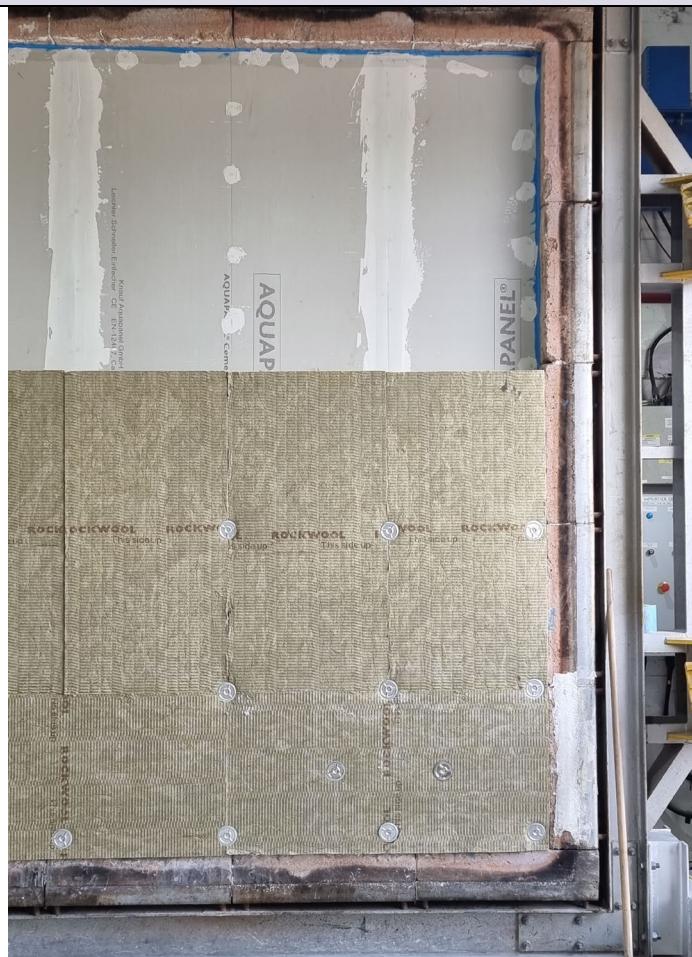
**7 Insulation Board**

<b>Manufacturer</b>	Rockwool
<b>Reference</b>	RWA45
<b>Location</b>	Exposed Face Only
<b>Dimensions (w x h x d)</b>	1200 x 600 x 150
<b>Fixing(s)</b>	Evolution Fasteners @ perimeter and mid points (see appendix A.2)

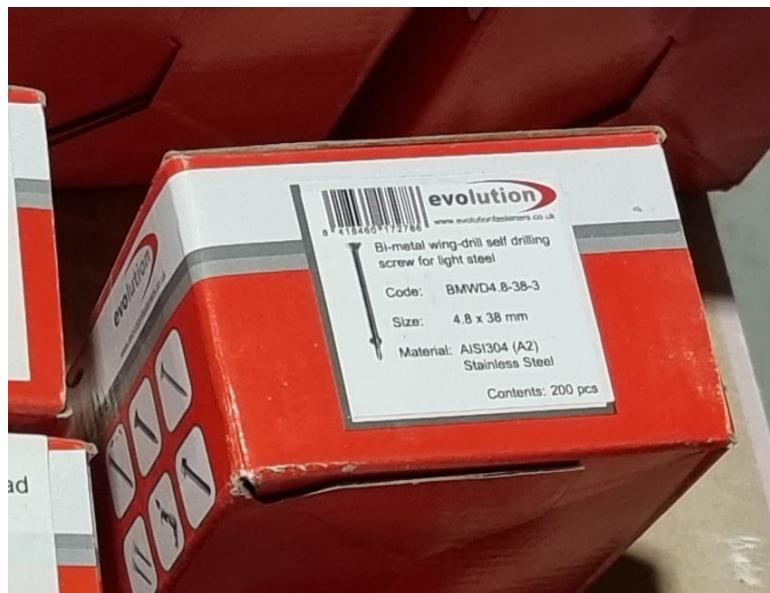
**8 Fixing (Inner wallboard exposed side)**

<b>Manufacturer</b>	Evolution
<b>Reference</b>	BMWD4.8 - 38 -3
<b>Material</b>	AISI 304 (A2) Stainless Steel
<b>Dimensions (Ø X L)</b>	Ø4.8 x 38

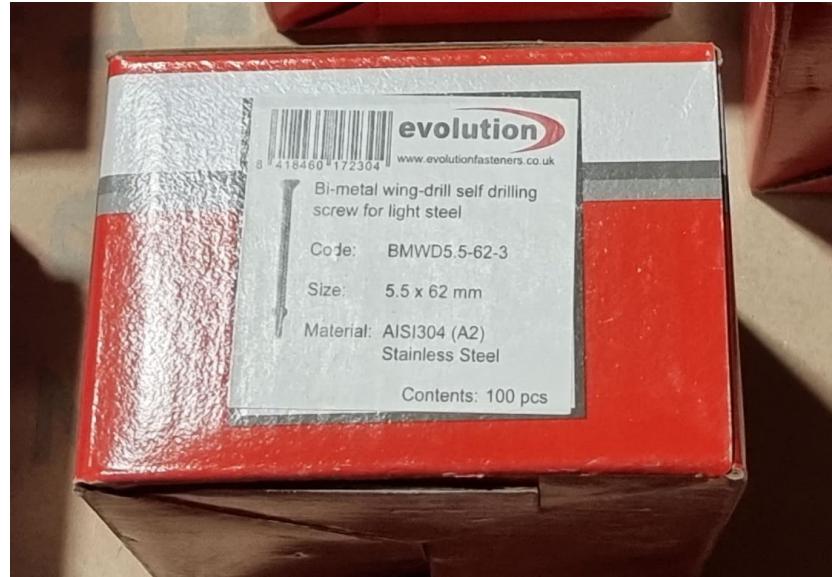
**9 Fixing (Outer wallboard Exposed Side)**

<b>Manufacturer</b>	Evolution
<b>Reference</b>	BMWD5.5 – 62 - 3
<b>Material</b>	AISI 304 (A2) Stainless Steel
<b>Dimensions (Ø x l)</b>	Ø5.5 x 62

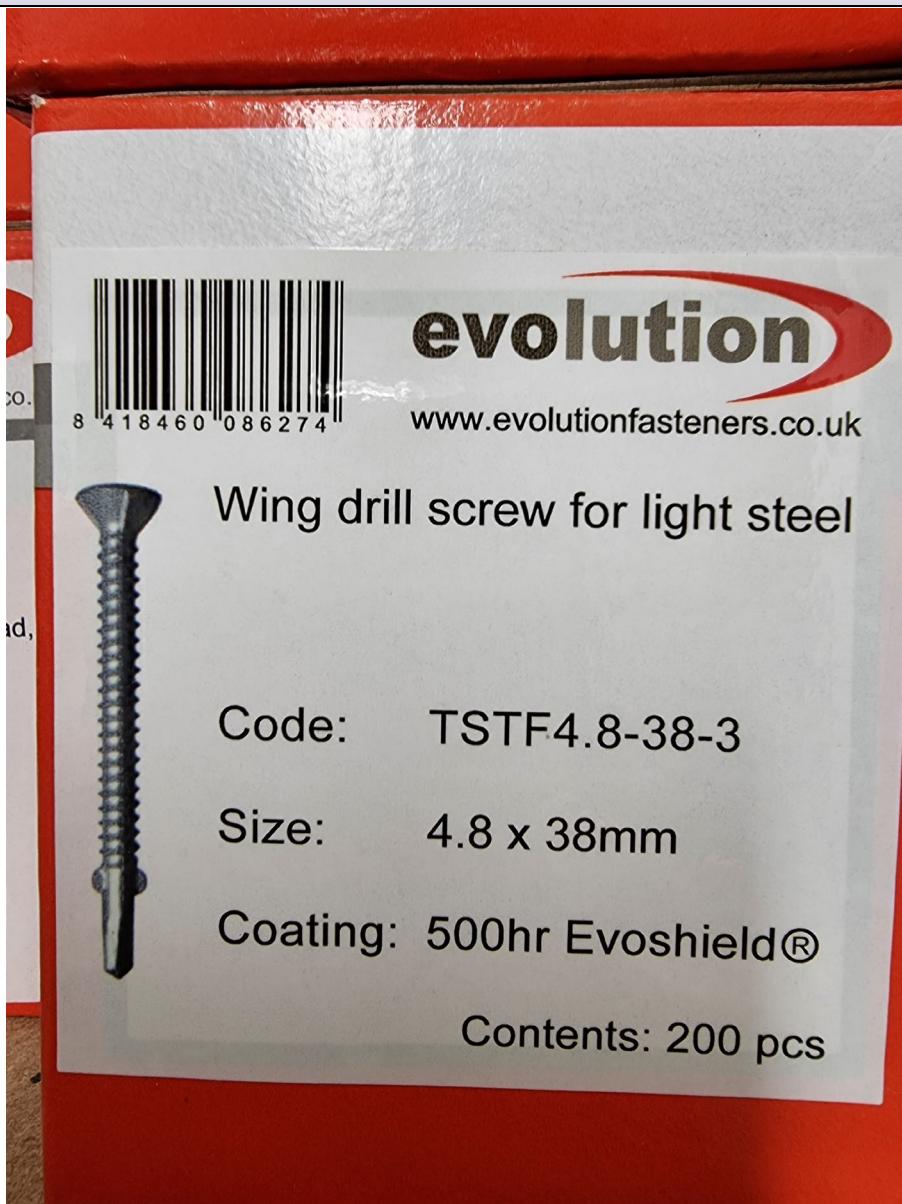
**10 Fixing (Inner Wallboard Unexposed Side)**

<b>Manufacturer</b>	Evolution
<b>Reference</b>	TSTF4.8 – 38 - 3
<b>Material</b>	C1022 Carbon Steel with 500 Hr EvoShield® coating
<b>Dimensions (Ø X L)</b>	Ø4.8 x 38
<b>Special Features</b>	Coating – 500hr Evoshield

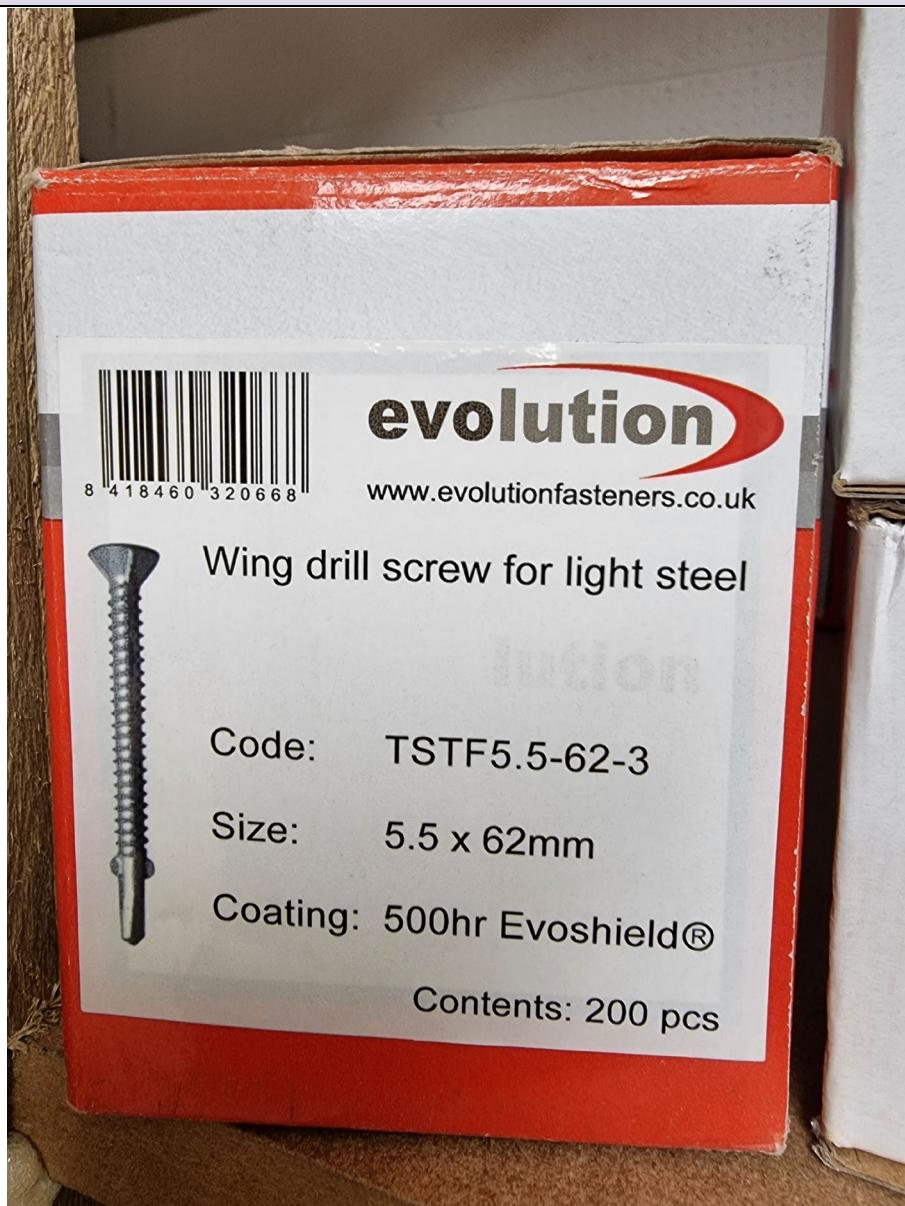
**11 Fixing (Outer Wallboard Unexposed Side)**

<b>Manufacturer</b>	Evolution
<b>Reference</b>	TSTF5.5 – 62 - 3
<b>Material</b>	C1022 Carbon Steel with 500 Hr EvoShield® coating
<b>Dimensions (Ø x l)</b>	Ø5.5 x 62
<b>Special Features</b>	Coating – 500 Hr EvoShield®

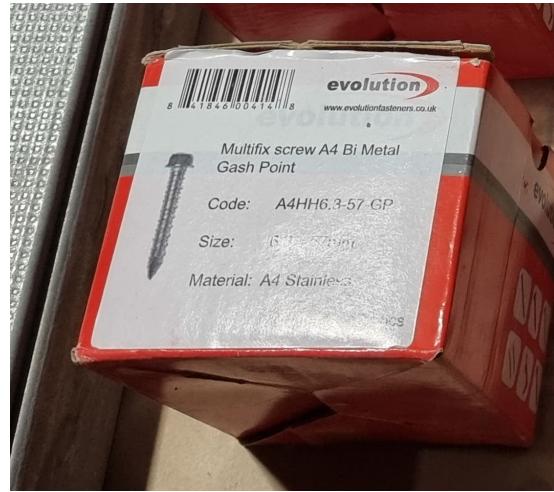
**12 Fixing (Ceiling Track)**

<b>Manufacturer</b>	Evolution
<b>Reference</b>	A4HH6.3 – 57 - 516
<b>Material</b>	AISI 316 (A4) Stainless Steel
<b>Dimensions (Ø x l)</b>	Ø6.3 X 57mm
<b>Special Features</b>	Coating – Electrodeposited zinc (passivated)

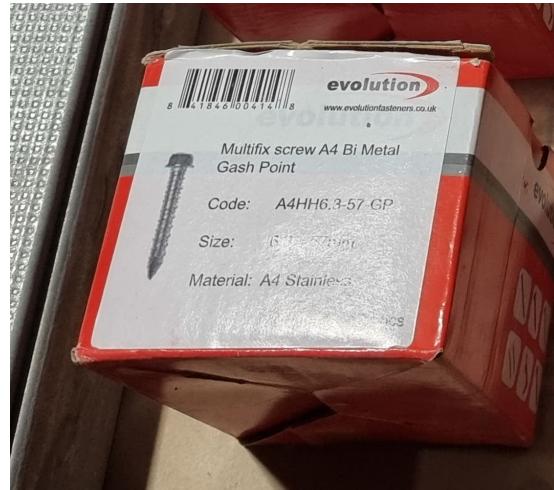
**13 Fixing (Floor Track)**

<b>Manufacturer</b>	Evolution
<b>Reference</b>	A4HH6.3 – 57 - 516
<b>Material</b>	AISI 316 (A4) Stainless Steel
<b>Dimensions (Ø x l)</b>	Ø6.3 x 57
<b>Special Features</b>	Coating – Electrodeposited zinc (passivated)

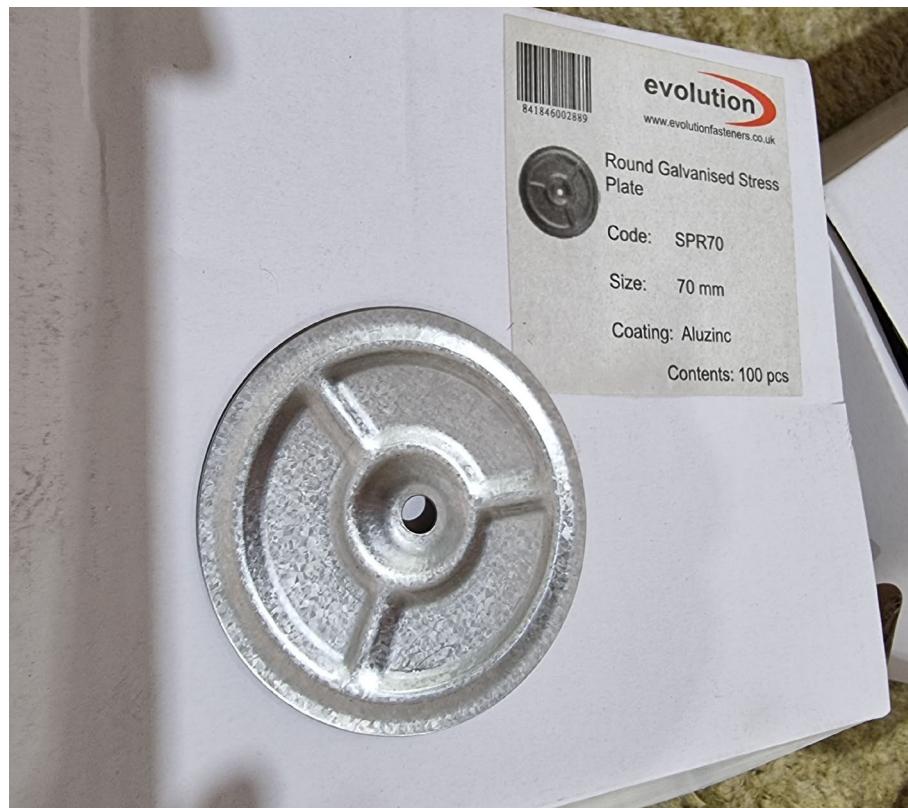
**14 Insulation Board Fixing (Perimeter)**

<b>Manufacturer</b>		Evolution
<b>Reference</b>	<b>Washer</b>	SPR70
	<b>Fastener</b>	IS220
<b>Material</b>	<b>Washer</b>	Galvanised Steel with Aluzinc coating
	<b>Fastener</b>	C1022 Carbon Steel with 500 Hr EvoShield® coating
<b>Dimensions</b>	<b>Washer</b>	Ø70
	<b>Fastener</b>	Ø4.8 x 220
<b>Location</b>		Perimeter of Insulation slab @ 600mm C/C
