# Test Report

Project ID: 20210322-001718

<b>Test Sponsor:</b>	Evolution Fasteners
<b>Sponsor Address:</b>	2A & 2B Clyde Gateway Trade Park Dalmarnock Rd Rutherglen Glasgow G73 1AN
<b>Date of Test:</b>	30 June 2021

The specimen had overall nominal dimensions of 3000 mm wide by 3050 mm high by 272 mm thick and was formed from 72 mm deep Metsec steel stuck framing and 25 mm thick Knauf mineral wool insulation, lined with two layers of 12.5 mm thick Knauf Aquapanel wallboard to each side. 150 mm thick Rockwool insulation panels were affixed to the unexposed surface. The specimen incorporated assorted Evolution Fasteners fixings.

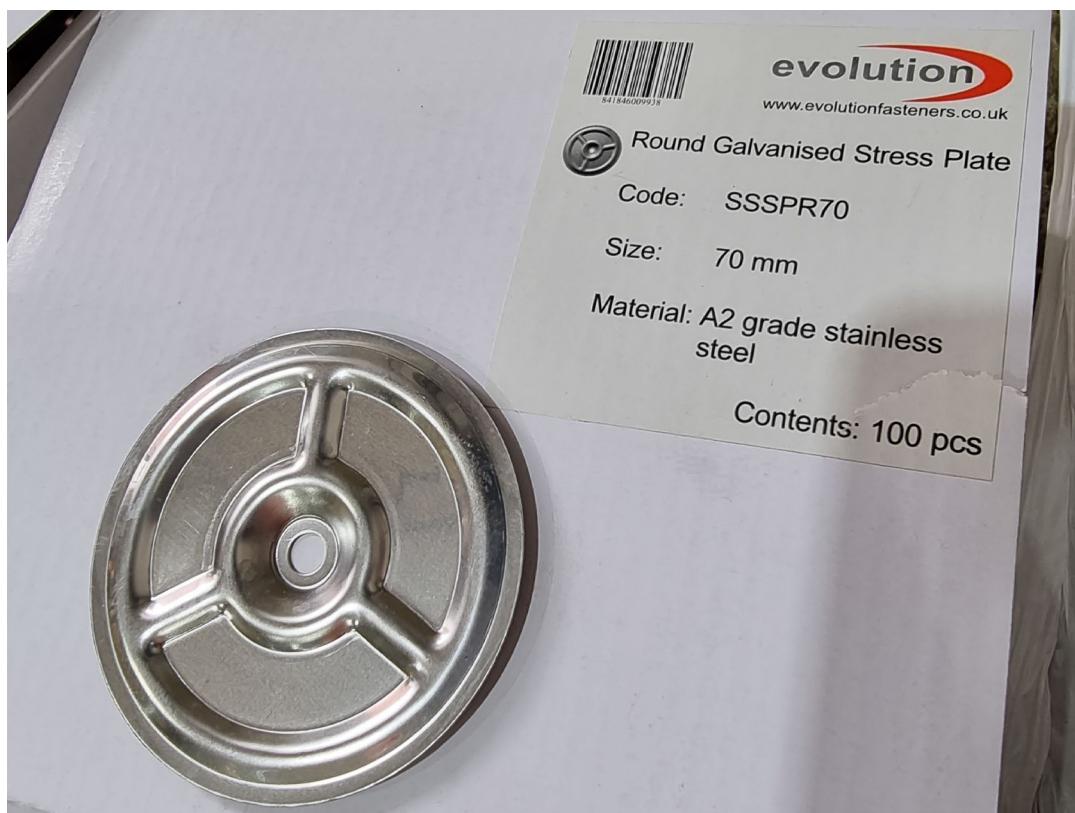
### 15 Insulation Slab Fixing (Middle)

<b>Manufacturer</b>		Evolution
<b>Reference</b>	<b>Washer</b>	SSSPR70
	<b>Fastener</b>	A4IS220
<b>Material</b>	<b>Washer</b>	AISI 304 (A2) Stainless Steel
	<b>Fastener</b>	AISI 316 (A4) Stainless Steel
<b>Dimensions (w x h)</b>	<b>Washer</b>	Ø70
	<b>Fastener</b>	Ø4.8 x 220
<b>Location</b>		2 Nr Centrally fixed @ 400mm C/C

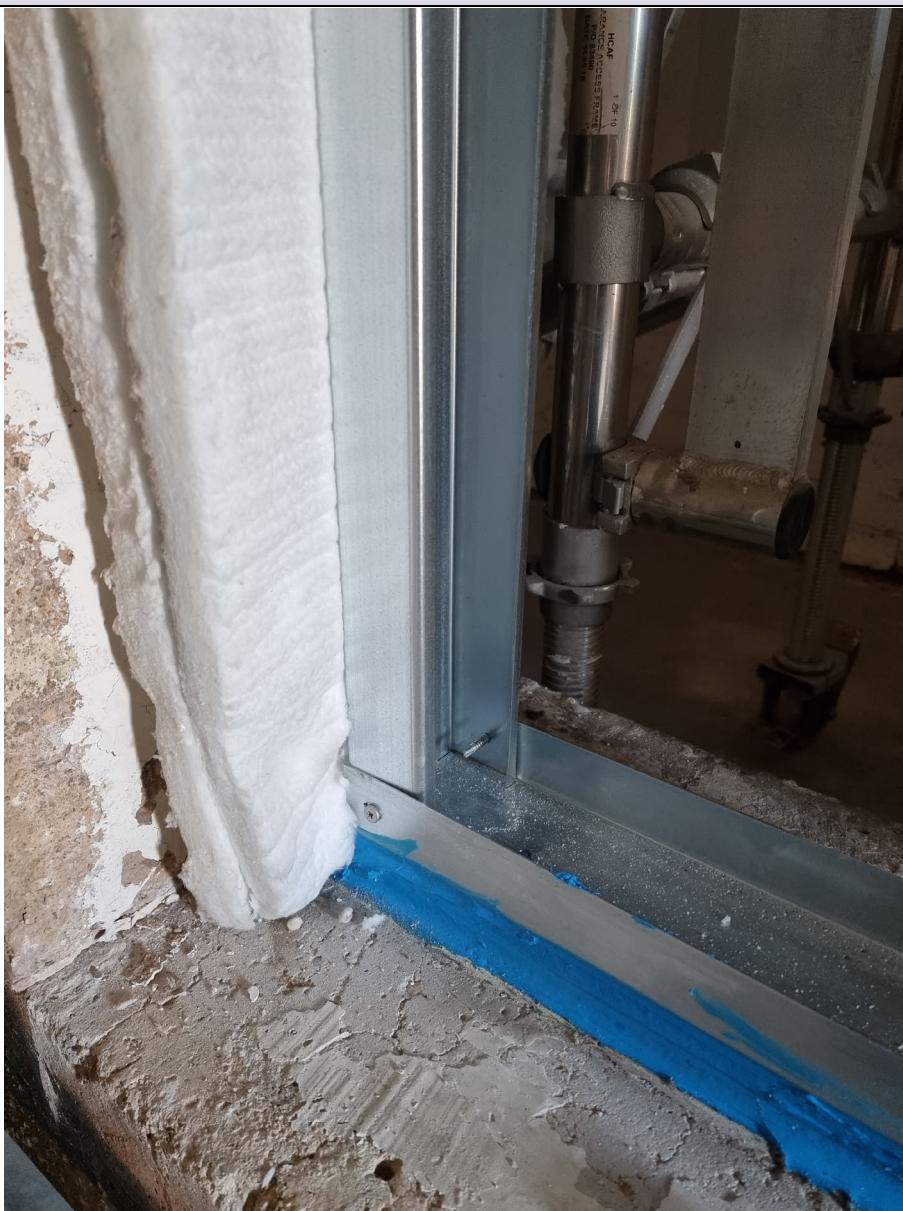
**16 Free Edge Gasket**

<b>Manufacturer</b>	Morgan Advanced Materials
<b>Reference</b>	Superwool HT
<b>Dimensions (w x h x d)</b>	150 x 3050 x 25
<b>Fixing(s)</b>	Compression fitted between supporting construction and restraint frame

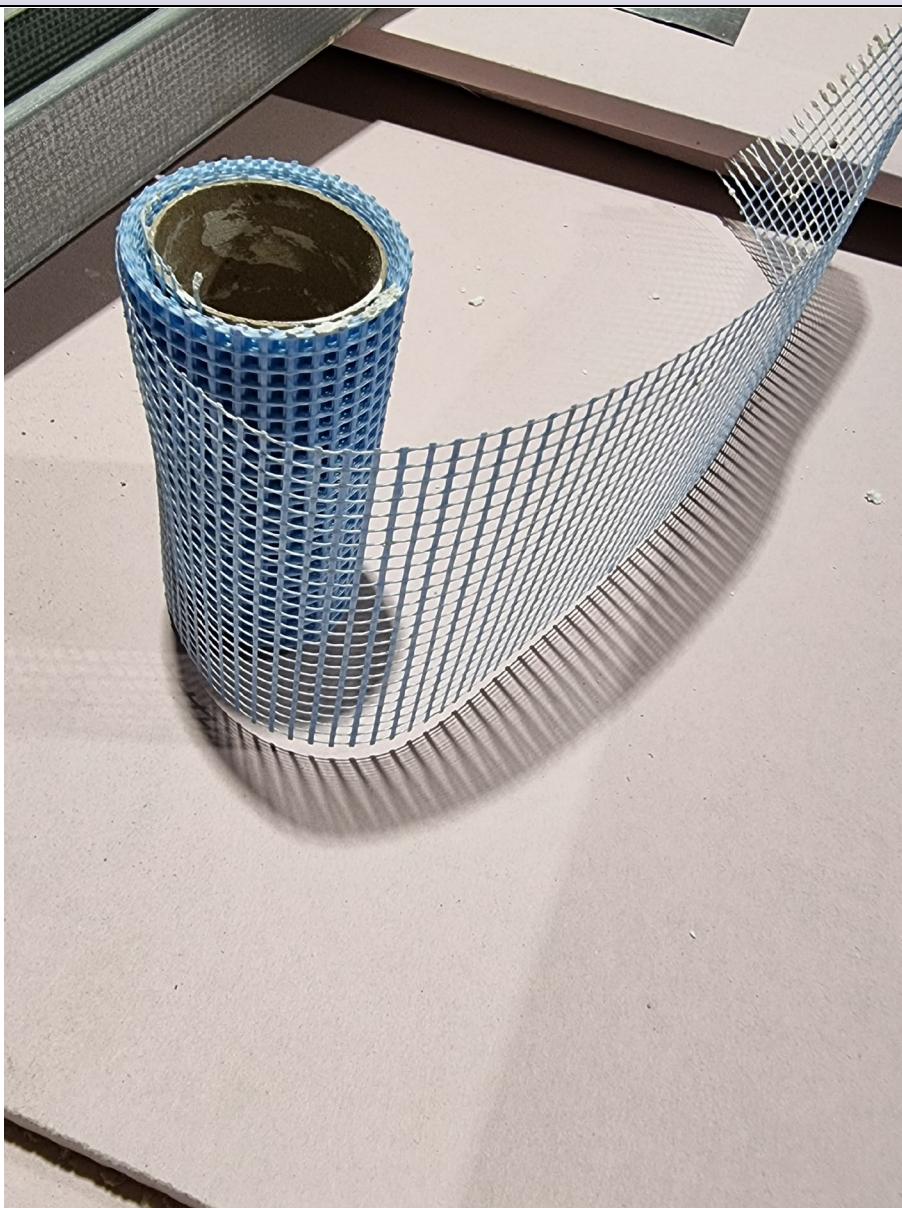
**17 Joint Tape**

<b>Manufacturer</b>	Knauf
<b>Reference</b>	Aquapanel Tape
<b>Material</b>	Glass Fibre with alkaline coating
<b>Dimensions (w x l)</b>	100 x 2100mm
<b>Location</b>	Board Joints
<b>Fixing(s)</b>	Embedded to Aquapanel Joint Filler

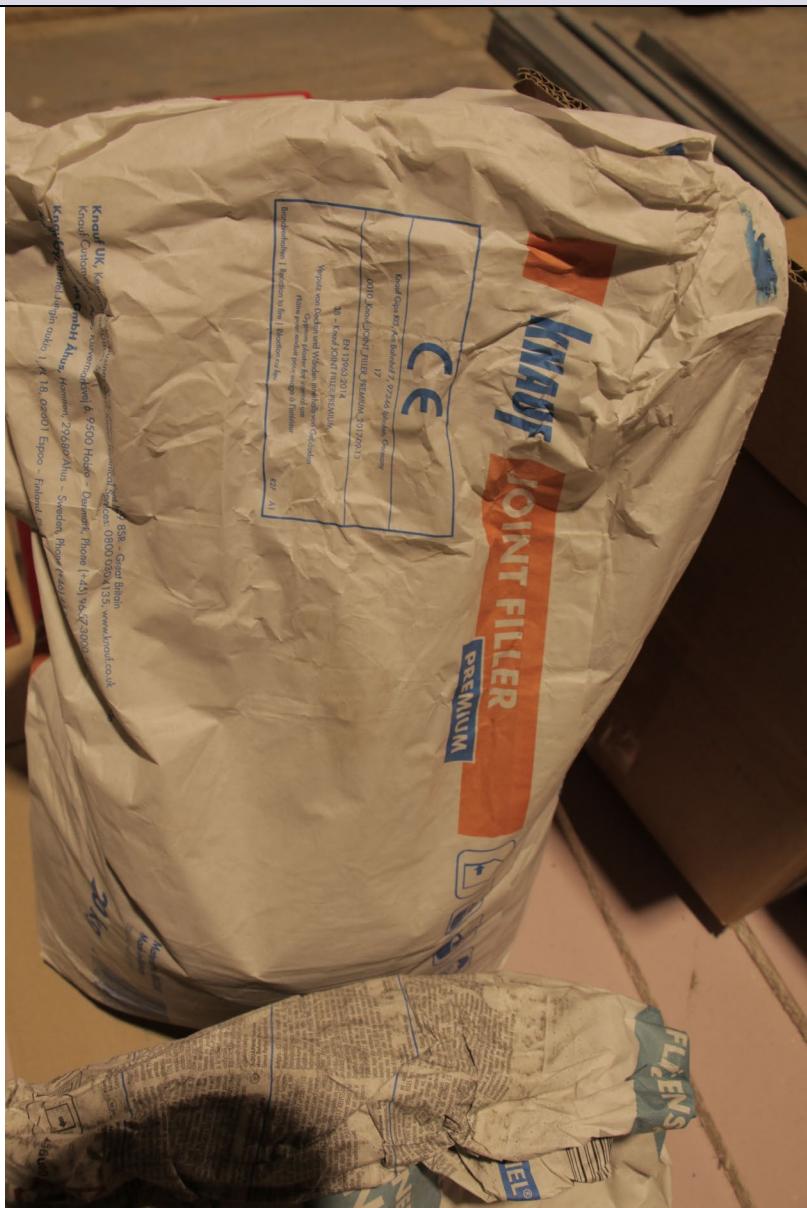
## 18 Joint Filler

<b>Manufacturer</b>	Knauf
<b>Reference</b>	Aquapanel Joint Filler and Skim Coat - White
<b>Weight/Bag</b>	20kg
<b>Application</b>	Trowel applied to joints and screw holes

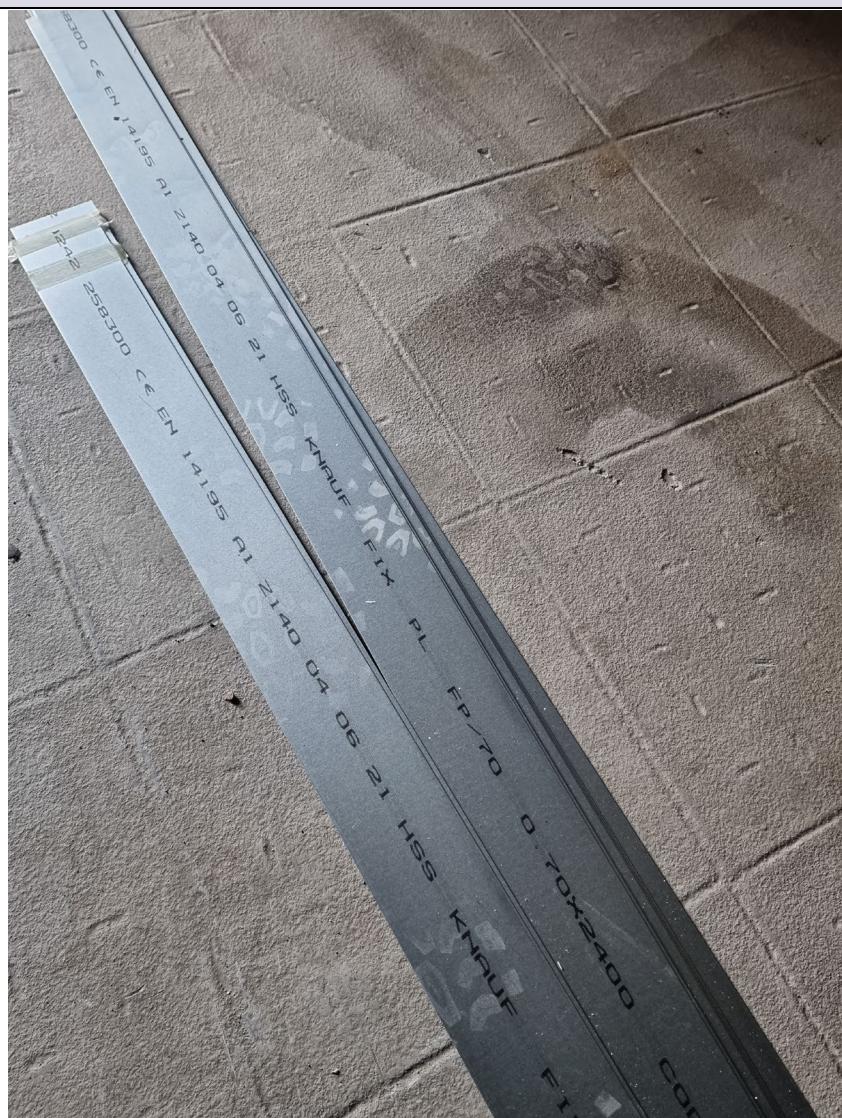
**19 Fixing Plate**

<b>Manufacturer</b>		Knauf
<b>Reference</b>		Flat Fixing Plate - 258300
<b>Dimensions (w x l x t)</b>		70 x 2400 x 0.7
<b>Material</b>		Steel
<b>Fixing(s)</b>	<b>Unexposed Side</b>	BMW D5.5 – 62 – 3 Wing Drill Screws
	<b>Exposed Side</b>	TSTF4.8 – 38 – 3 Wing Drill Screws
<b>Location</b>		300, 600, 1000, 1400, 2200, 2600 mm from bottom of partition to centreline of plate

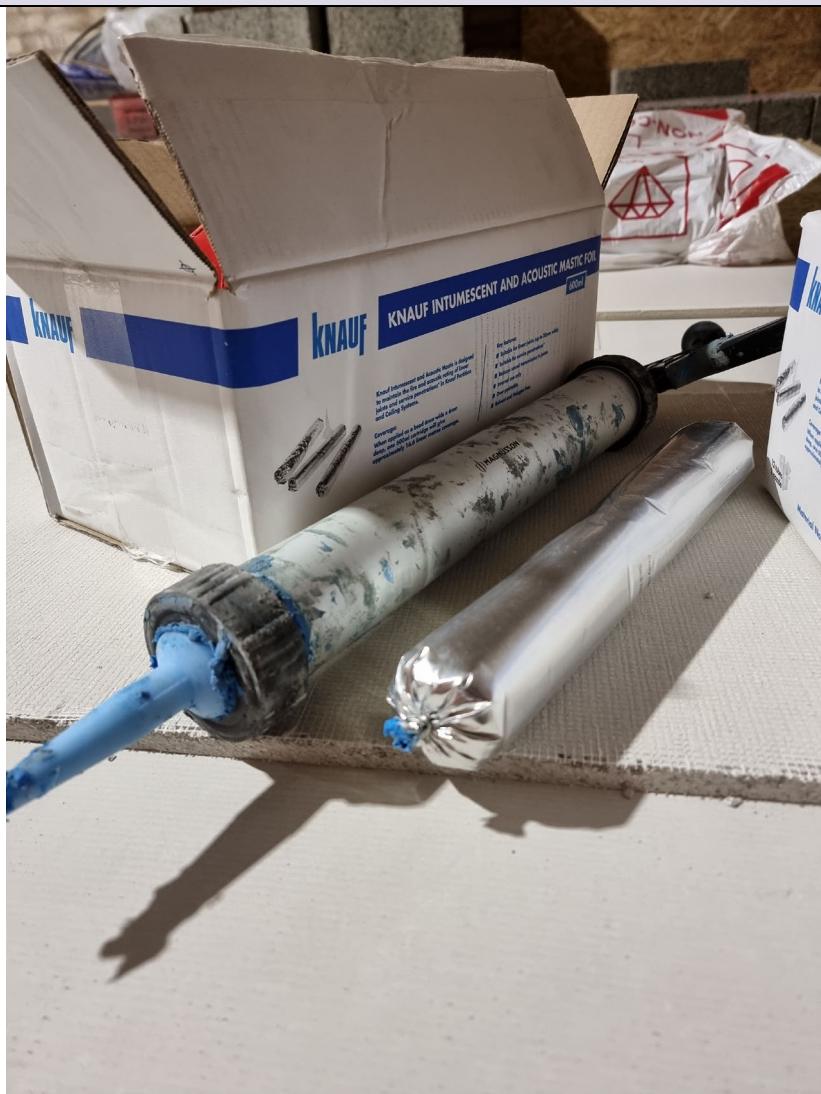
**20 Fire Stopping**

<b>Manufacturer</b>	Knauf
<b>Reference</b>	Intumescent & Acoustic Mastic
<b>Description</b>	600 ml foil packed
<b>Application</b>	Applied with mastic gun
<b>Location</b>	Junction between - frame and Aquaboard; frame and Floor/Ceiling Track; frame and Stud at the fixed edge

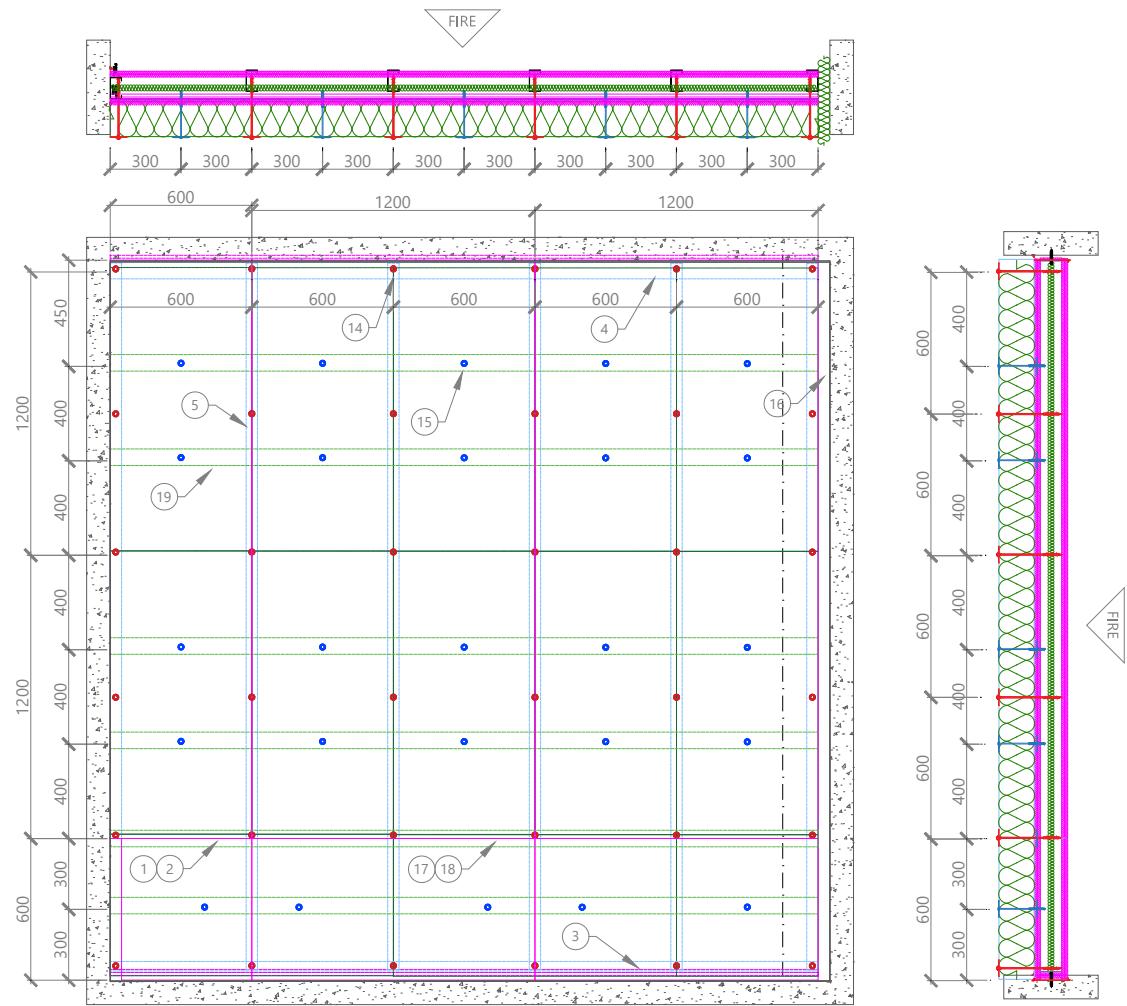
A.2. 1 - General arrangement of test construction

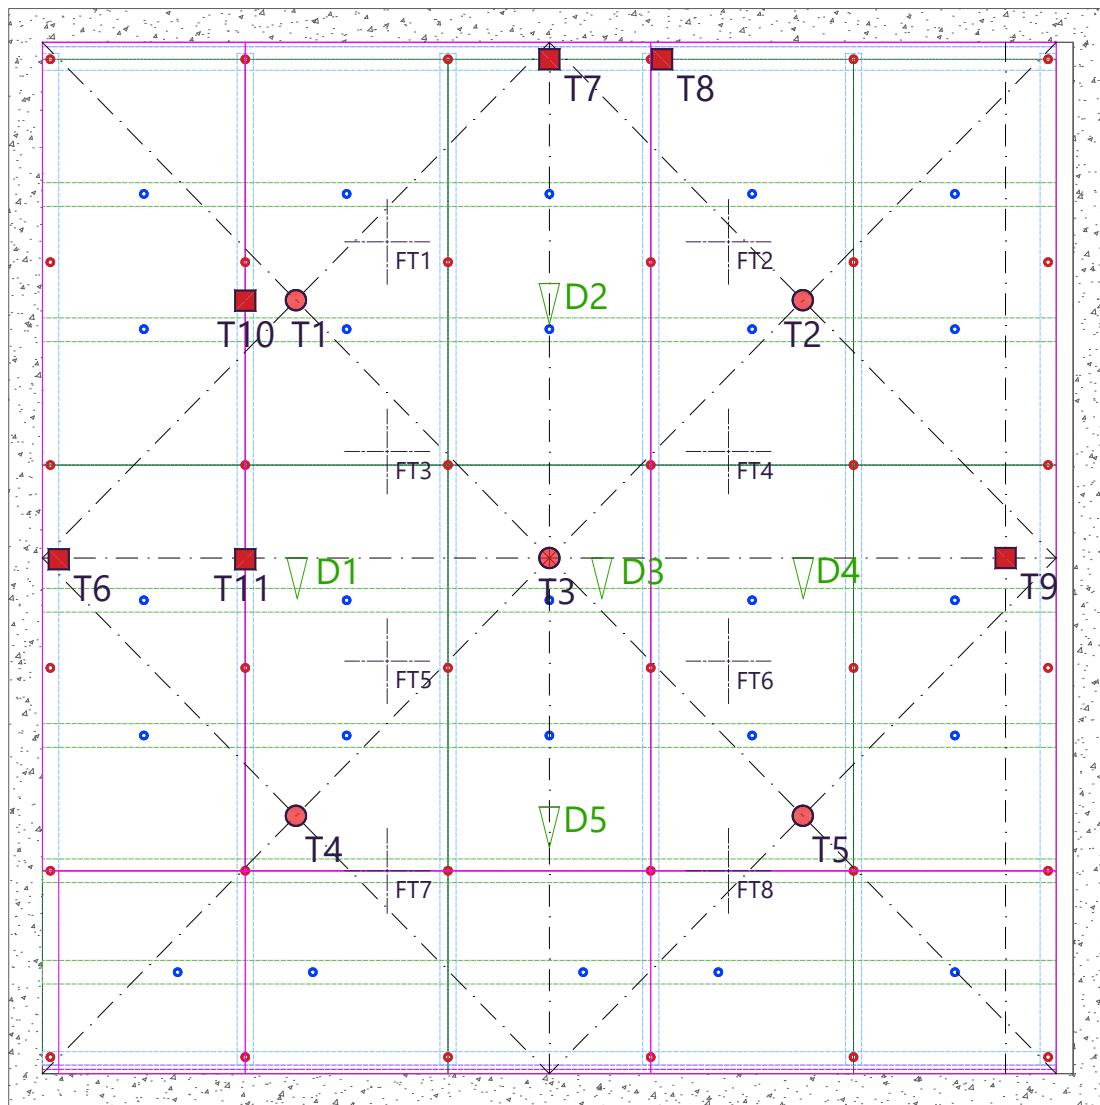
A.2. 2 - Layout of instrumentation when viewed from the unexposed surface of the test construction

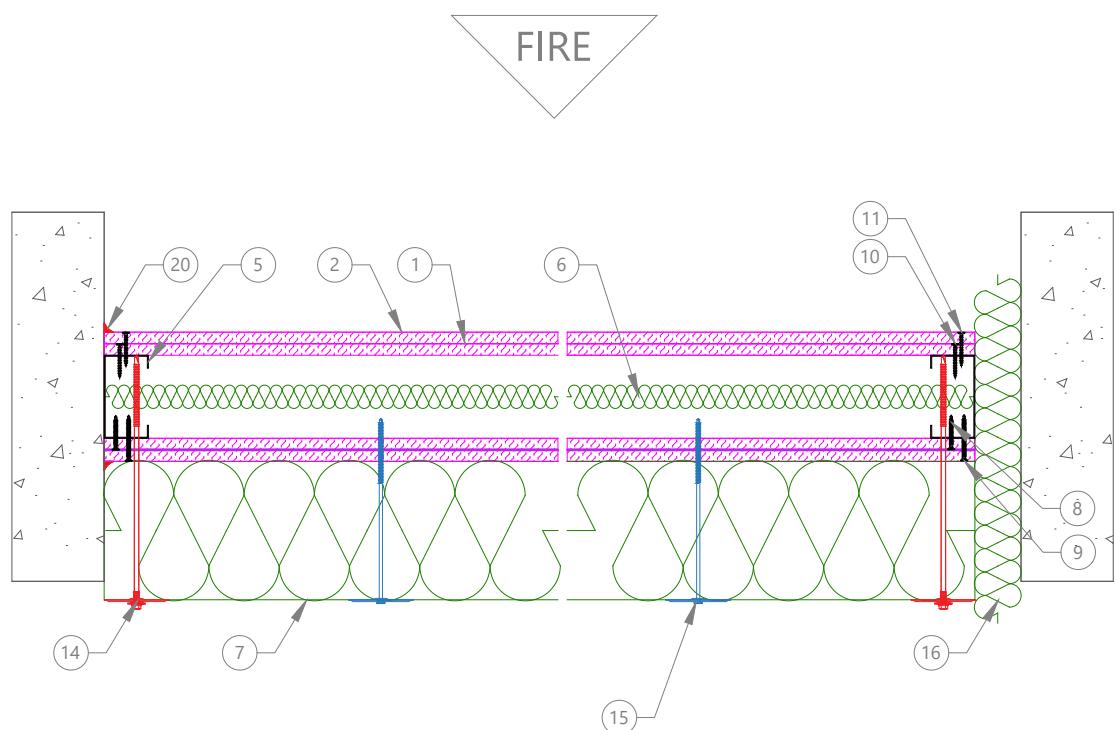
A.2. 3 - Typical horizontal section through the specimen

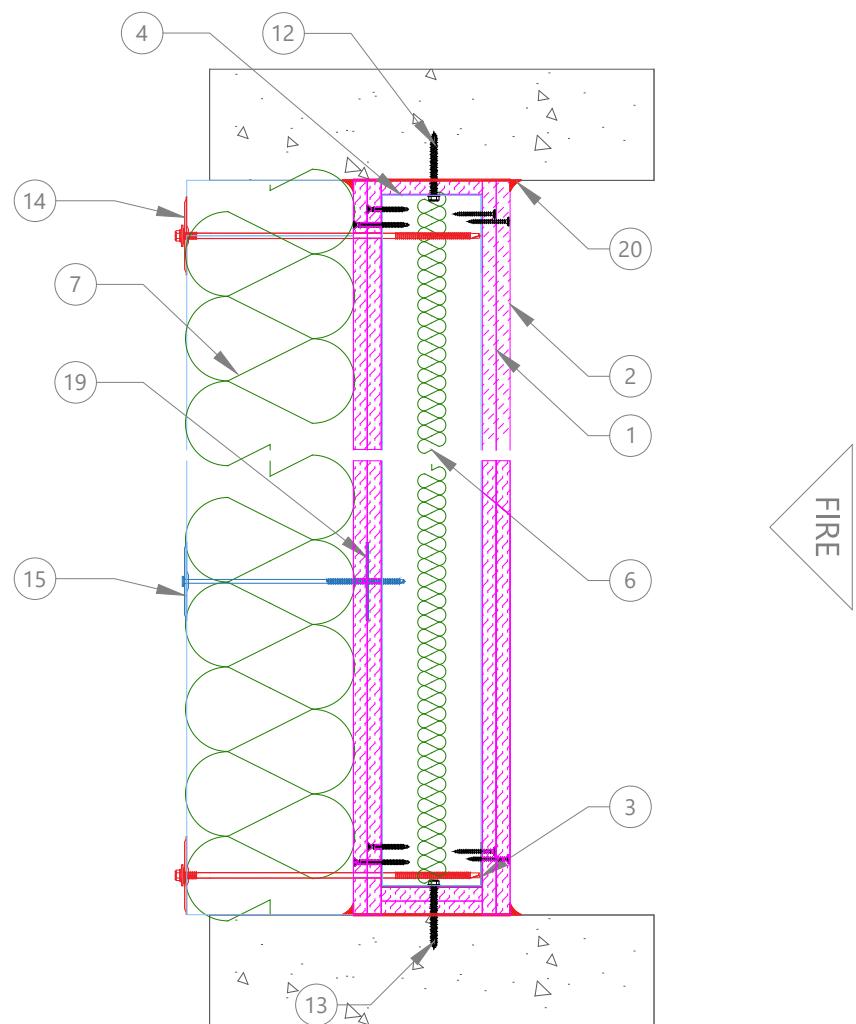
A.2. 4 - Typical vertical section through the specimen
